TECHNICAL REPORT ARLCD-TR-81016

EVALUATION OF CONTINUOUS-CAST STEEL FOR PROJECTILE BODIES

US ARMY ARMAMENT RESEARCH AND DEVELOPMENT COMMAND
LARGE CALIBER
WEAPON SYSTEMS LABORATORY
DOVER, NEW JERSEY

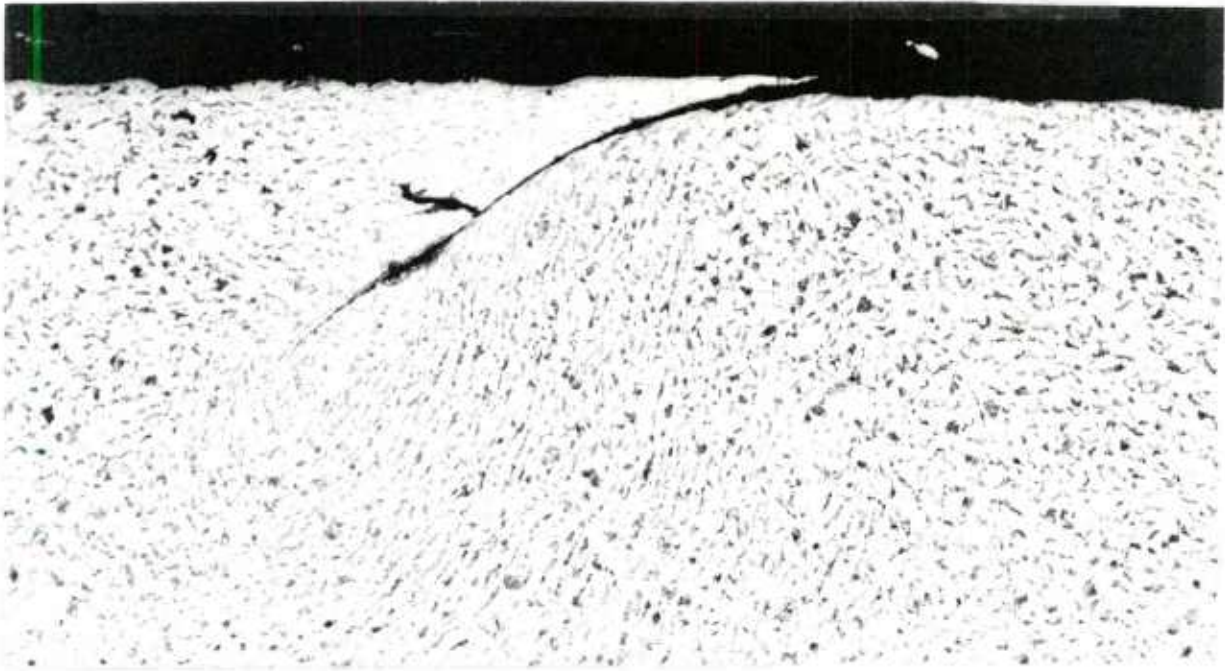
Figure 17. Microstructure of magnetic particle indication of nosing defect, picral etch - Republic Steel (100X)

The principle disadvantage of magnetic-particle inspection is the difficulty in determining depth or severity from a surface indication. These projectile bodies had already passed through inspection station CD-1 at National Presto, which requires a 100% visual inspection, and had been accepted. Representative projectile bodies with magnetic-particle indications were selected and returned to Frankford Arsenal for metallurgical evaluation. Of all the projectile bodies examined, only one appeared to have a crack, which occurred in the nose of the projectile body (figure 17). This crack is the remnant of a fold caused during nosing which did not clean up during the nose boring operation. Since the flow lines are perpendicular to the surface on the right of the crack, the indication is that a folding action has occurred.

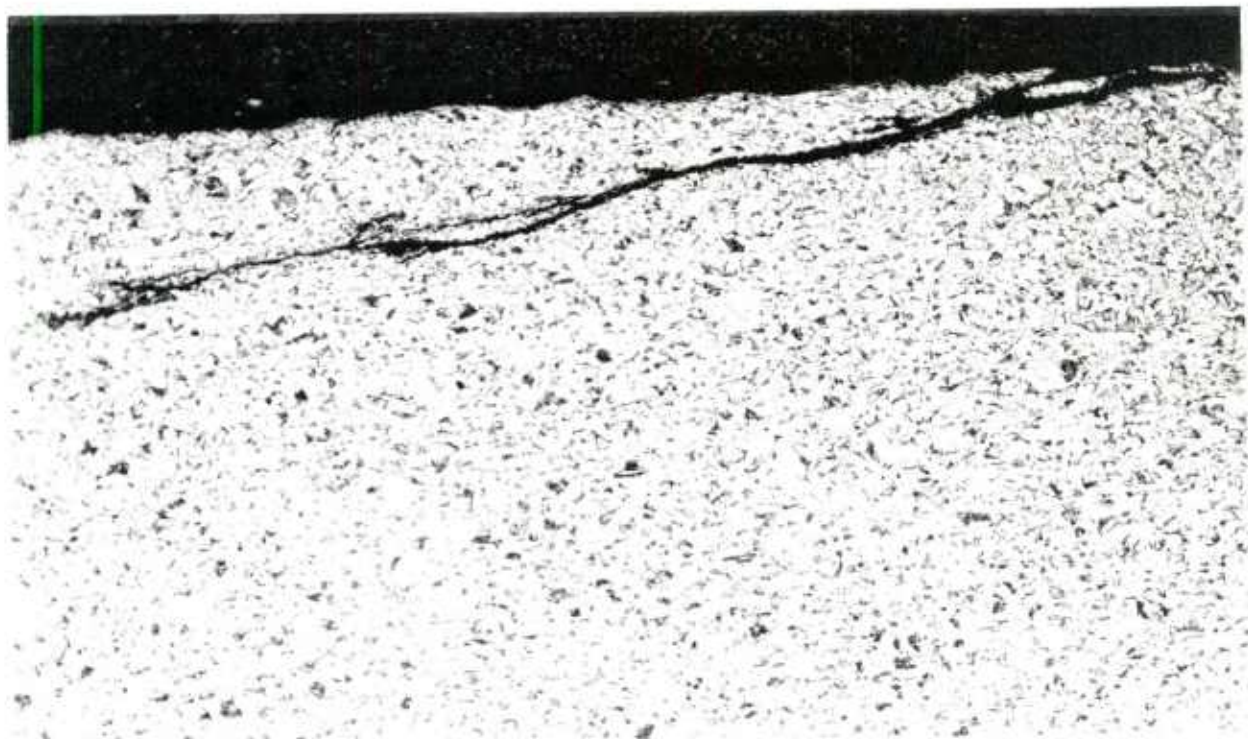
Figure 18. Microstructure of magnetic particle indication of band seat area, picral etch - Republic Steel (100X)

Typical remaining projectile bodies having magnetic-particle indications are shown in figures 18 through 20. The defect shown in figure 18 occurred just above the band seat and extends 0.25 mm (0.010 in.) below the surface. This defect appears to be a lap which would occur during the cold draw operation. The defect shown in figure 19 is another lap of lesser magnitude.

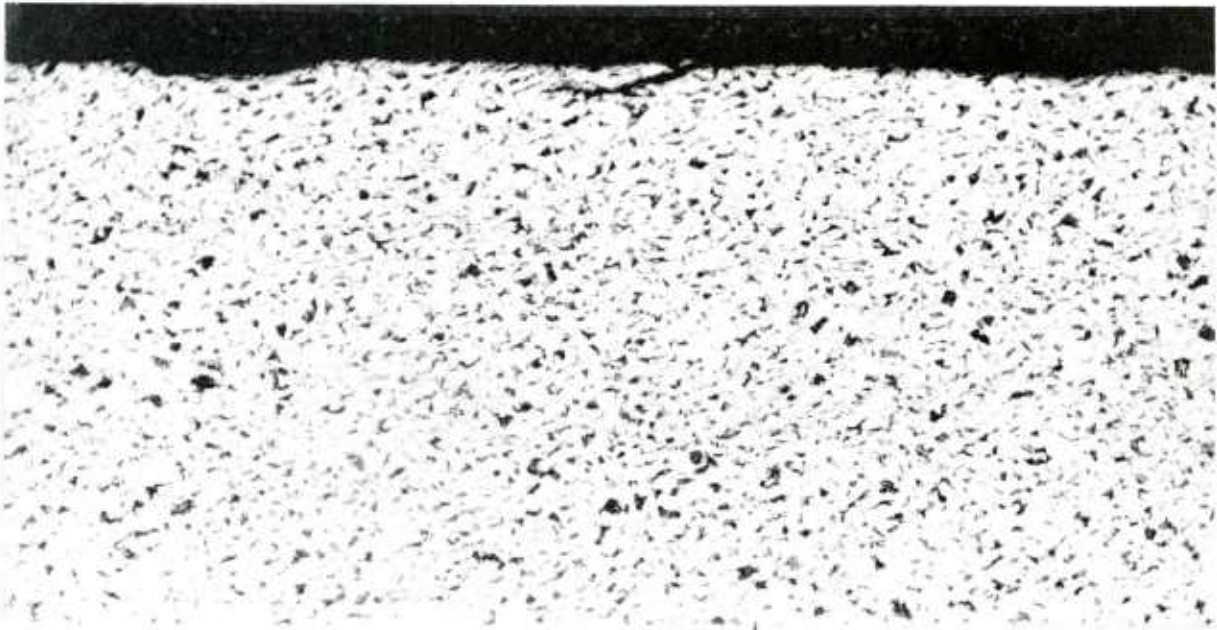
Figure 19. Lap-type defect revealed by magnetic particle testing, picral etch - Republic Steel (100X)

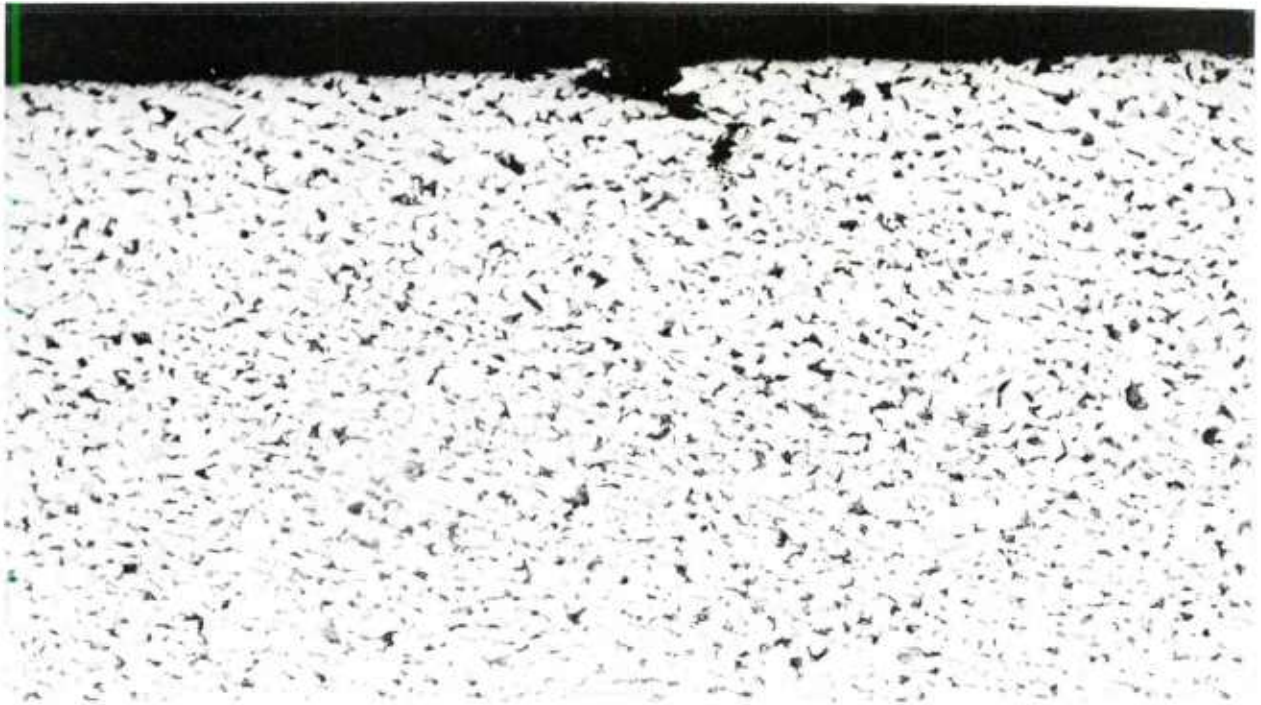
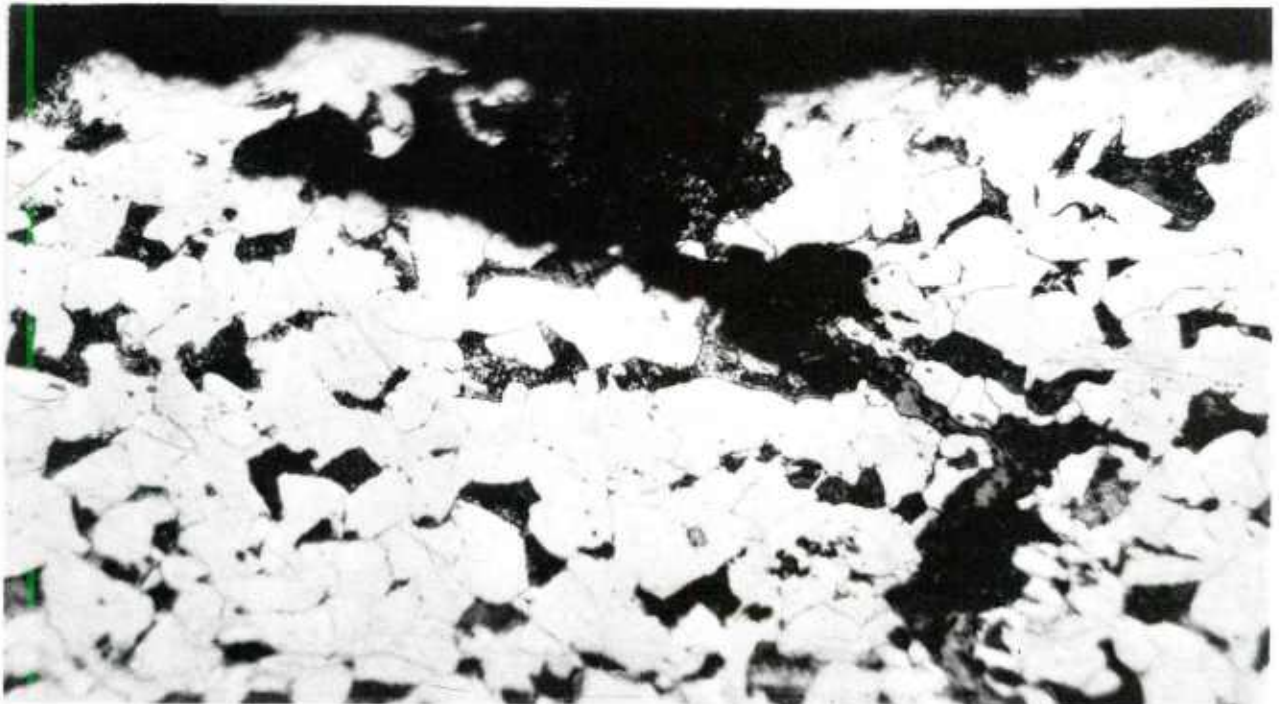
Figure 20. Remnant of seam revealed by magnetic particle testing, picral etch - Republic Steel (100X and 500X)

The defect in view A, figure 20, is the remnant of a seam in the bar stock, which was not completely removed during machining of the hot forged cup. Some iron oxide scale, associated with the defect, is evidenced in the higher magnification photograph in view B, figure 20. All of the defects indicated by magnetic-particle inspection, with the exception of the nose crack, would not interfere with the safe functioning of the projectile because of their orientation and shallow depth. The nose crack, however, is severe enough to warrant rejection of the projectile.

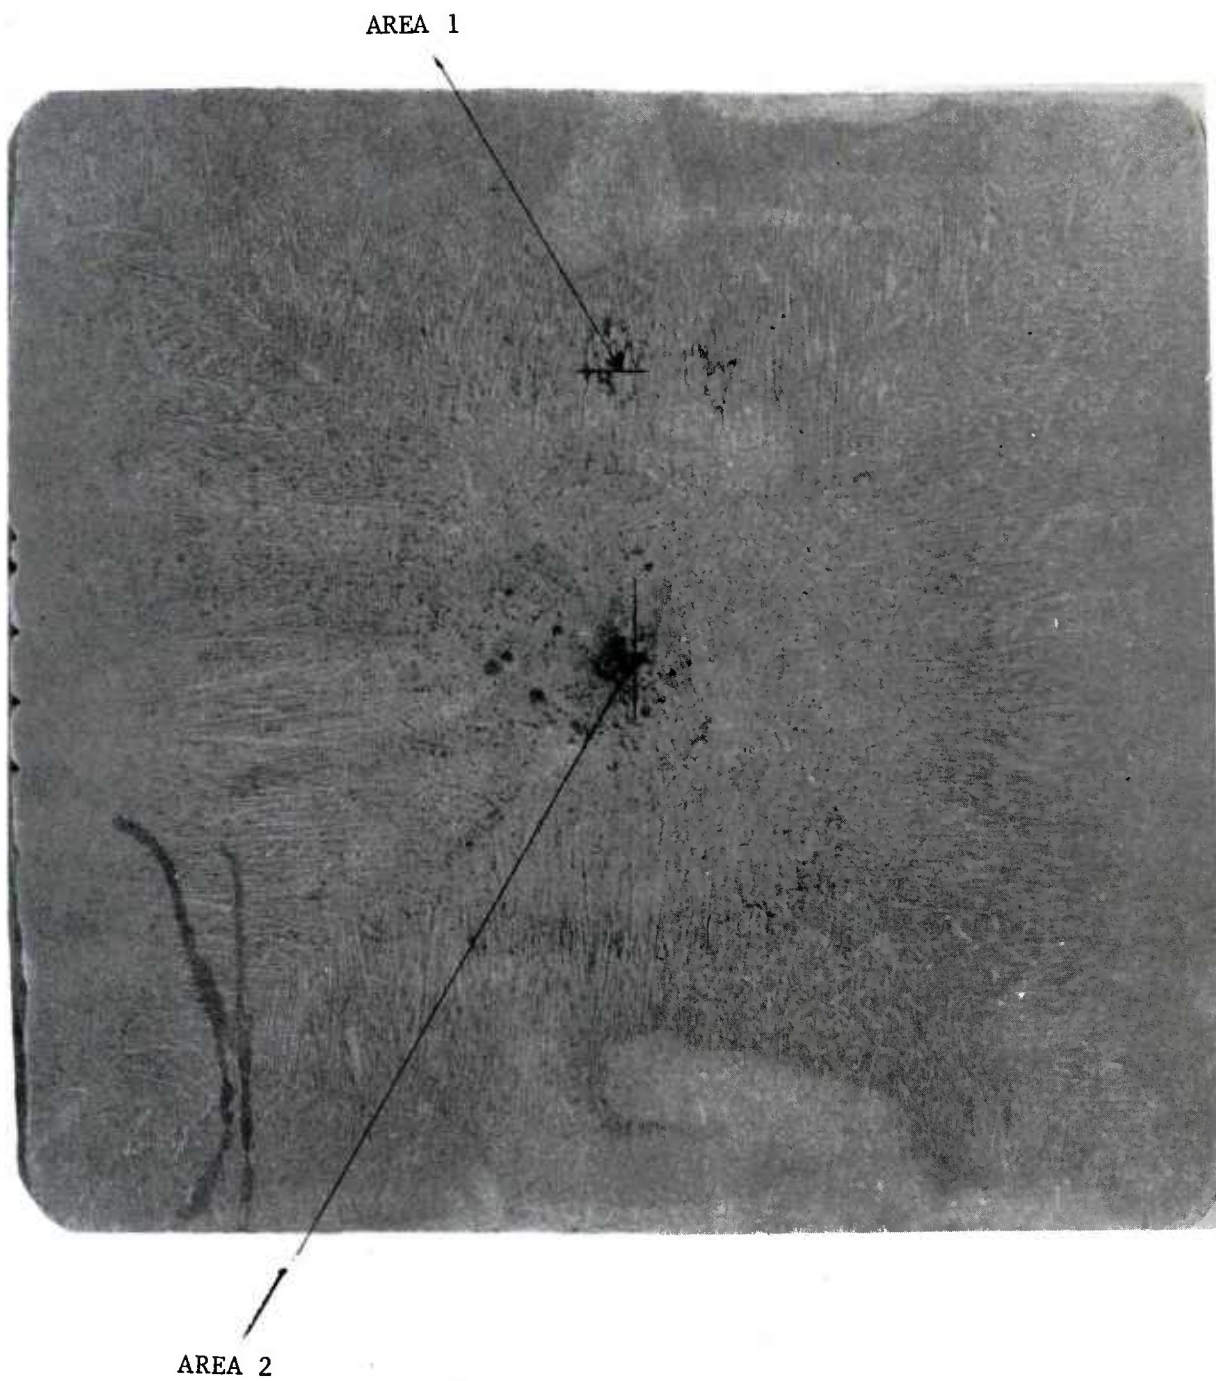
Figure 21. Macroetched bar section 1 - Roblin Steel (1.5X)

A macrograph of an unworked continuous-cast steel billet typical of the quality Roblin Steel produces is shown in figure 21. A coarse dendritic structure is evident; however, the soundness appears to be good. Areas 1 and 2 of figure 21 were selected for microscopic examination. Stains evident on the macrograph in area 1 indicated a small amount of porosity as shown in the unetched micrograph in figure 22. Area 2 represents the very center of the unworked continuous-cast steel billet and, from the macrograph, could have been interpreted as showing porosity. However, the micrograph of area 2 in figure 23 shows no porosity. The structure shows wiedmanstatten ferrite (white phase) and very fine pearlite (dark phase) which is indicative of an unworked continuous-cast steel structure. What appeared to have been porosity was an area of segregation which was attacked by the macroetch.

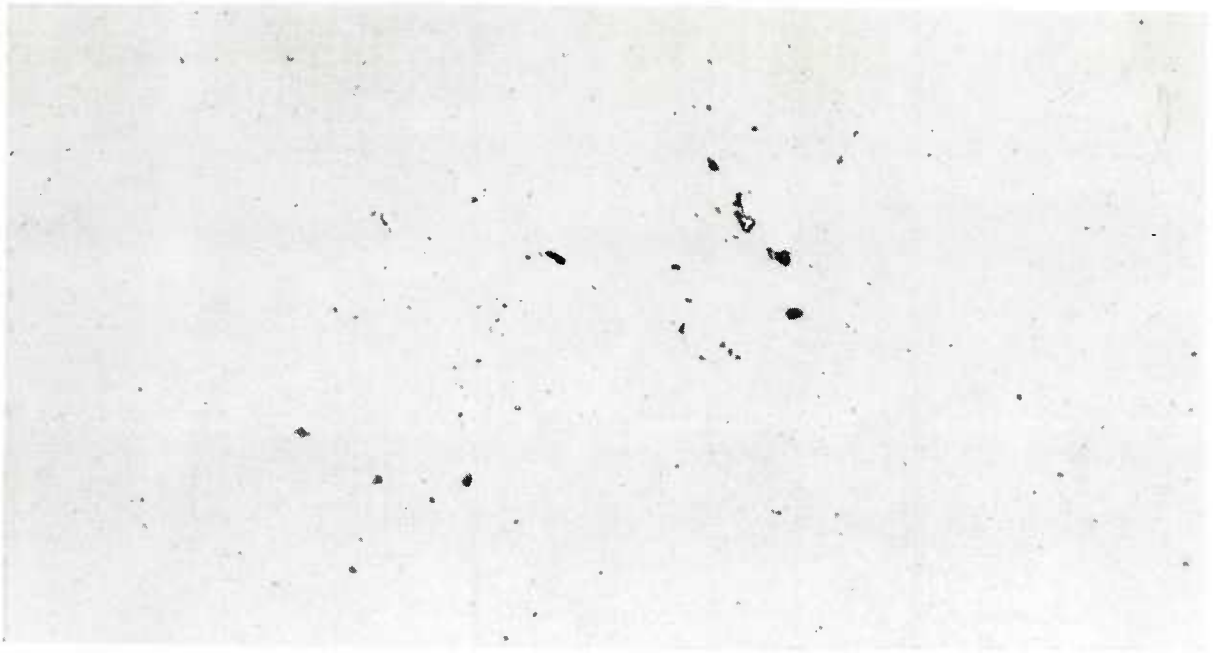
Figure 22. Porosity evident in area 1 of macroetched bar section 1 - Roblin Steel (100X)

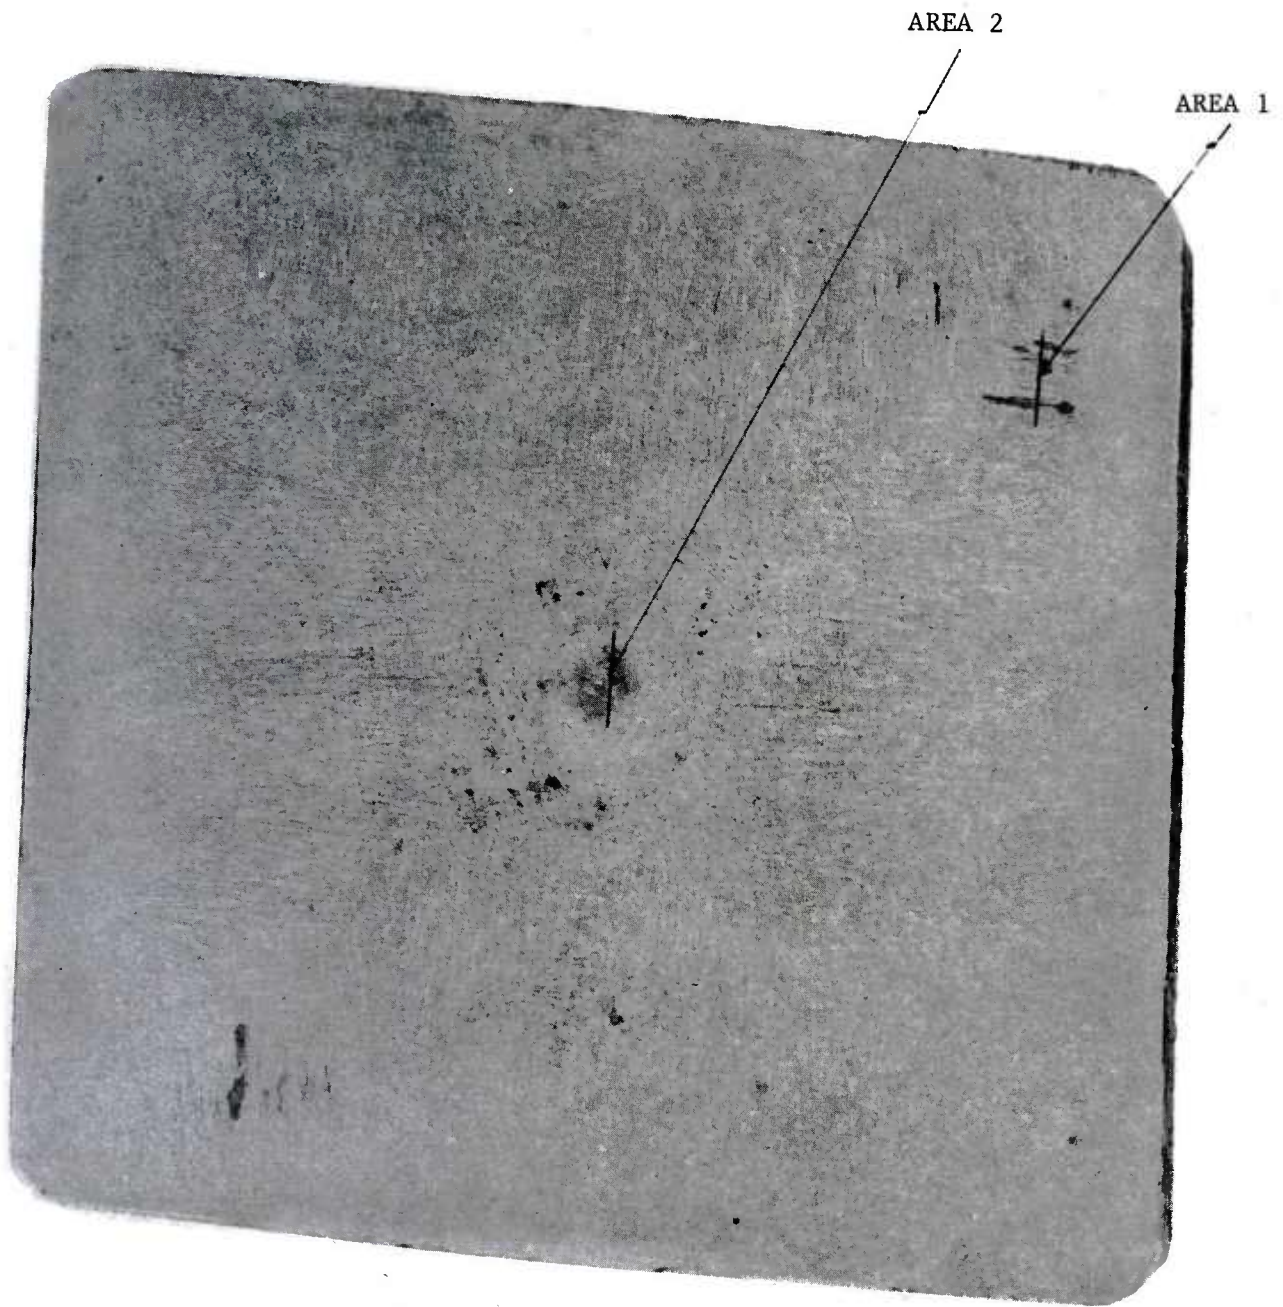
Figure 24. Macroetched bar section 2 - Roblin Steel (1.5X)

of figure 24 shows a stain which indicates a separation adjacent to a dendrite. This separation occurs when the volume of liquid metal between dendrites is not sufficient to fill the space upon solidification. Another cause is deformation of the unworked continuous-cast steel billet while liquid metal is remaining between dendrites. This deformation is caused by twisting of the billet while it is being extracted from the mold and by bending of the billet from a vertical position to a horizontal position. This condition is shown in figure 25 and is distinguished from a crack by its being a series of connected and disconnected voids. This type of defect will heal itself with subsequent hot working, because normally no oxides are associated with the voids. The center of the billet (fig. 26) also shows interdendritic porosity. The difference in microstructure on either side of the porous area is due to alloy segregation, with the alloy probably being manganese.

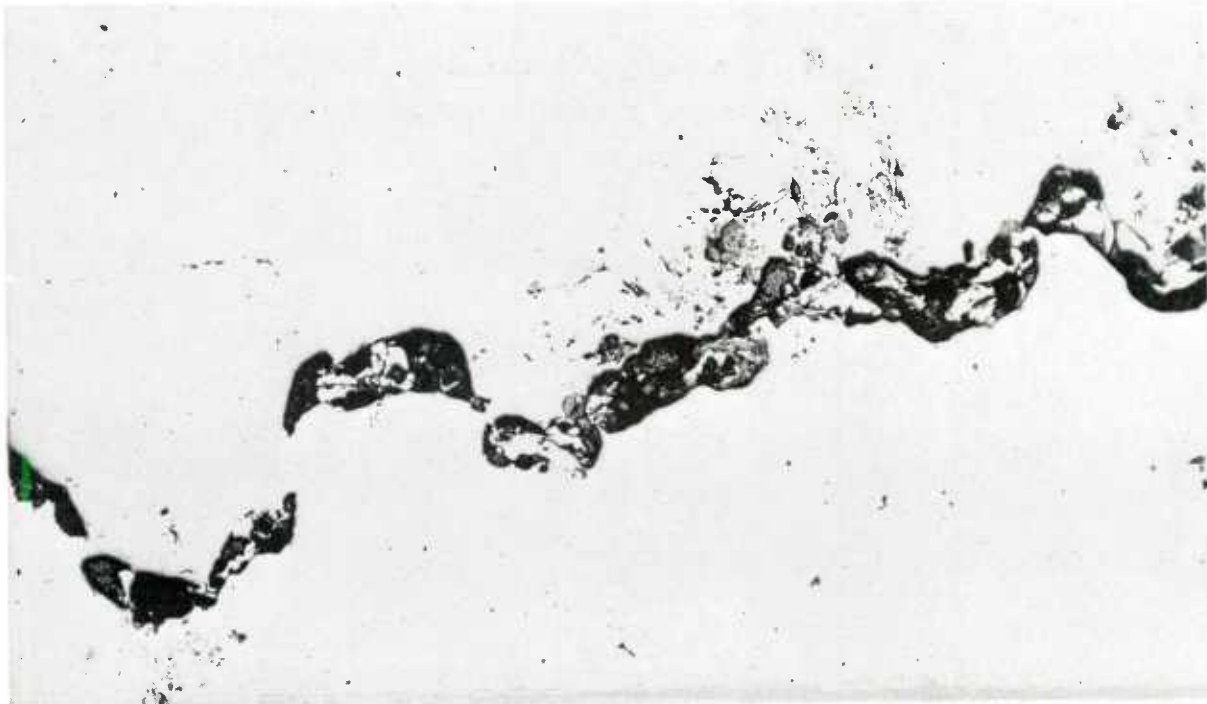
Figure 25. Discontinuities in area 1 of macroetched bar section 2 - Roblin Steel (100X)

Some scattered porosity was also evident in the base of the projectile body, as indicated in figure 37. This defect appears to be dendritic porosity which did not close during forging since the base does not undergo as much deformation as the sidewalls. A comparison of the microstructure in figure 37 with the microstructure in figures 22, 23, 25 and 26 shows the degree of refinement obtained by reheating for forging.

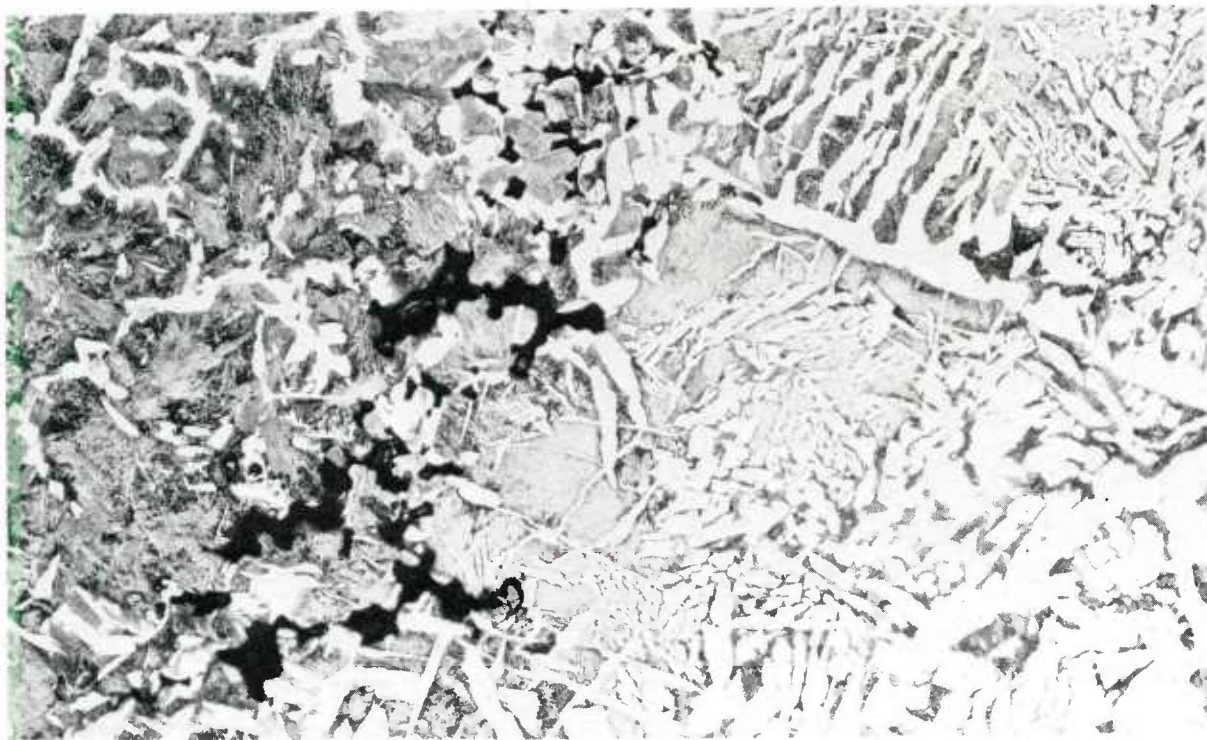
Figure 26. Porosity in area 2 (center) of macroetched bar section 2, picral etch - Roblin Steel (100X)

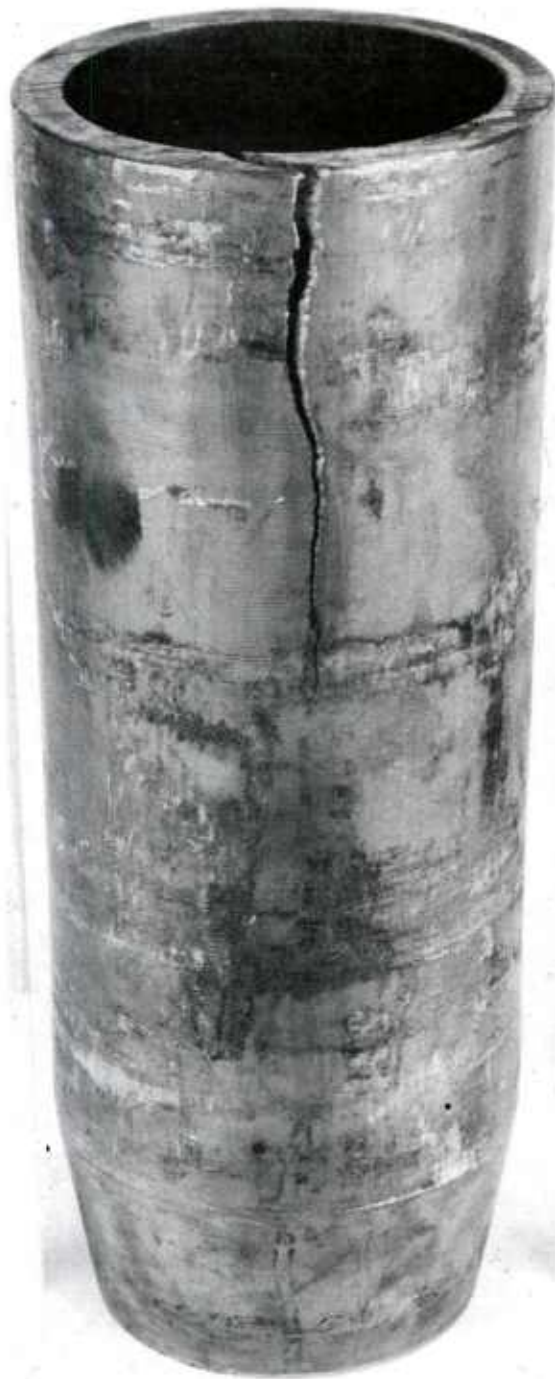
Figure 27. Defective forging made from Roblin Steel product

The unworked continuous-cast steel appeared to have less ductility in hot forging than the conventional AISI 1018 material. A forging made from the unworked continuous-cast steel, with a large crack starting at the open end, is shown in figure 27. Such defects occur occasionally with ingot steel, but the defects in those instances are due to seams in the surface of the bar. Unworked continuous-cast steel has excellent surface finish and, since this steel has not been rolled, the presence of seams is unlikely.

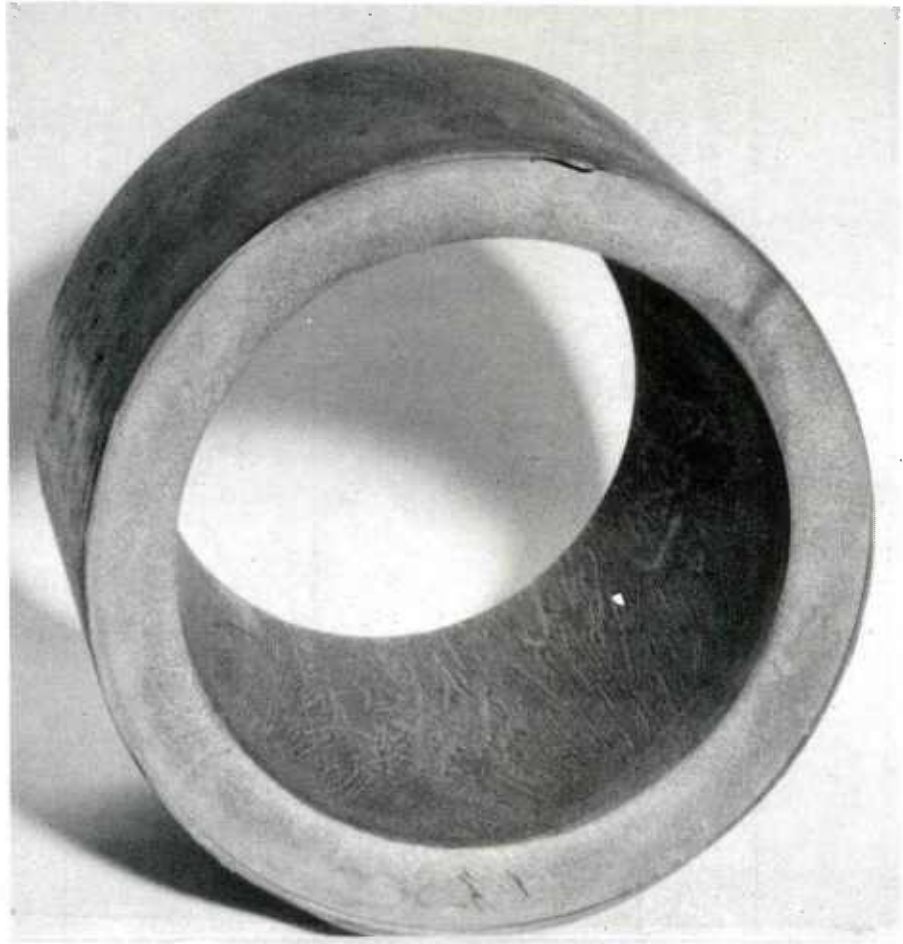
Figure 28. Cracks evident on open end of forging made from Roblin Steel product

Several mm of the open end of two other forgings were removed and macroetched (figures 28 and 29). Small cracks are evident on the face of the open end of the forging, and a coarse dendritic structure is also evident. Another view of the crack in figure 29 (fig. 30) shows small defects 180° apart. The defects occur at locations where the flow lines diverge; thus, the coarse dendritic structure results in greater directionality of properties, which would be a problem under production conditions. Microscopic examination of these small cracks did not shed any more light on their cause and did not show any massive inclusions which could have caused initiation of these cracks.

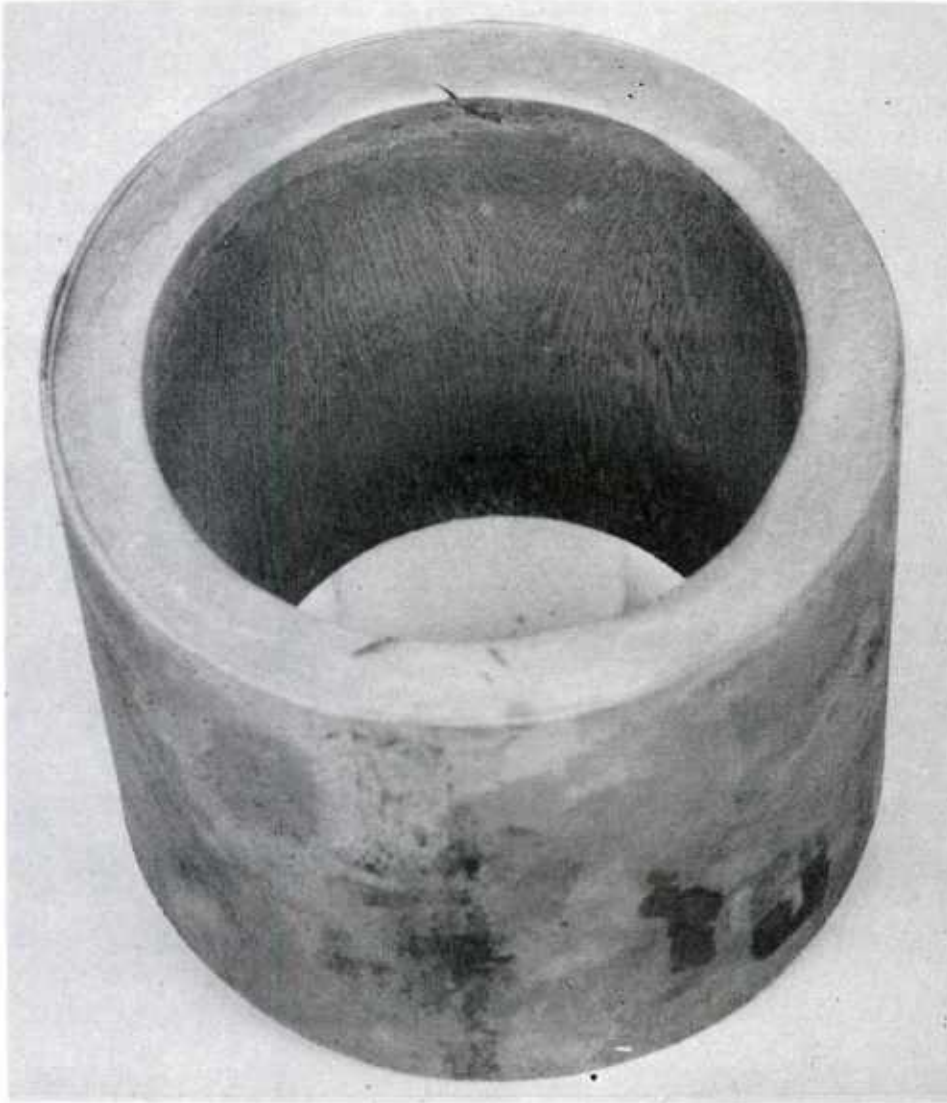
Figure 29. Cracks and divergent dendritic flow lines on forging made from Roblin Steel product

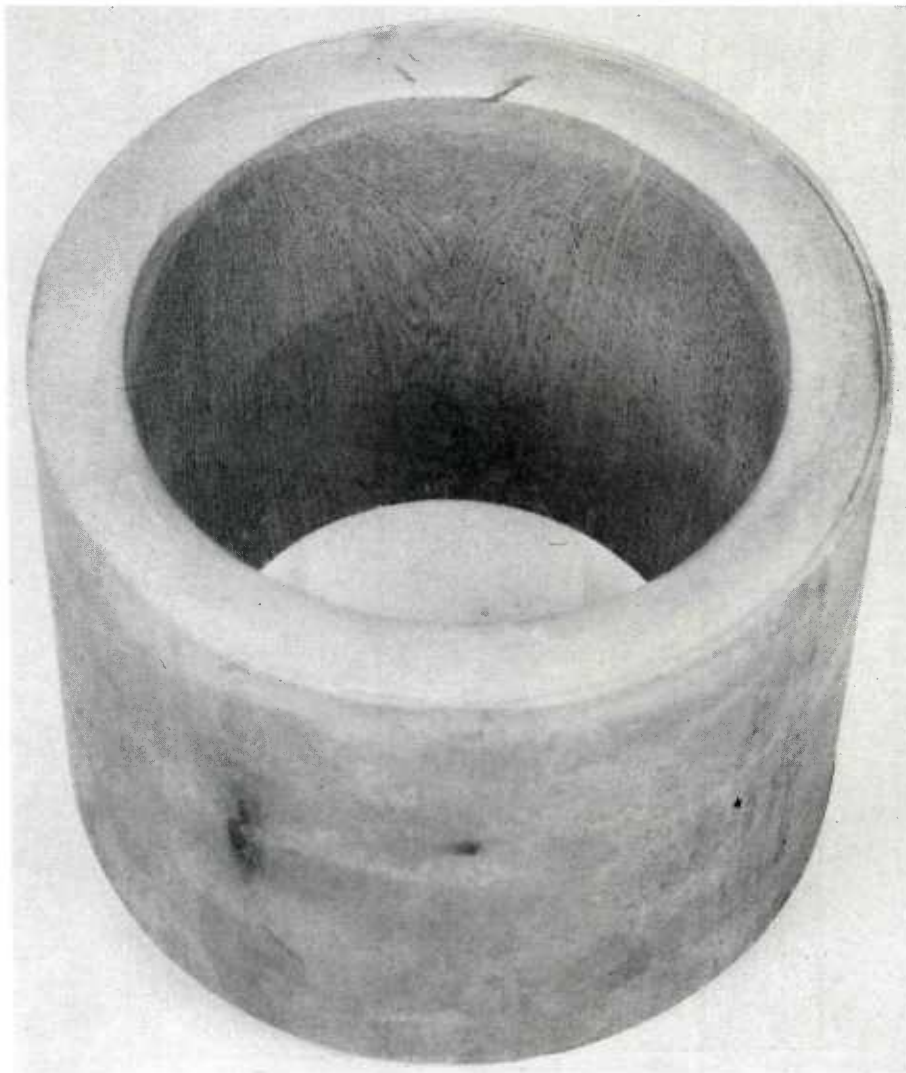
Figure 30. Opposite side view on forging shown in figure 29 - Roblin Steel

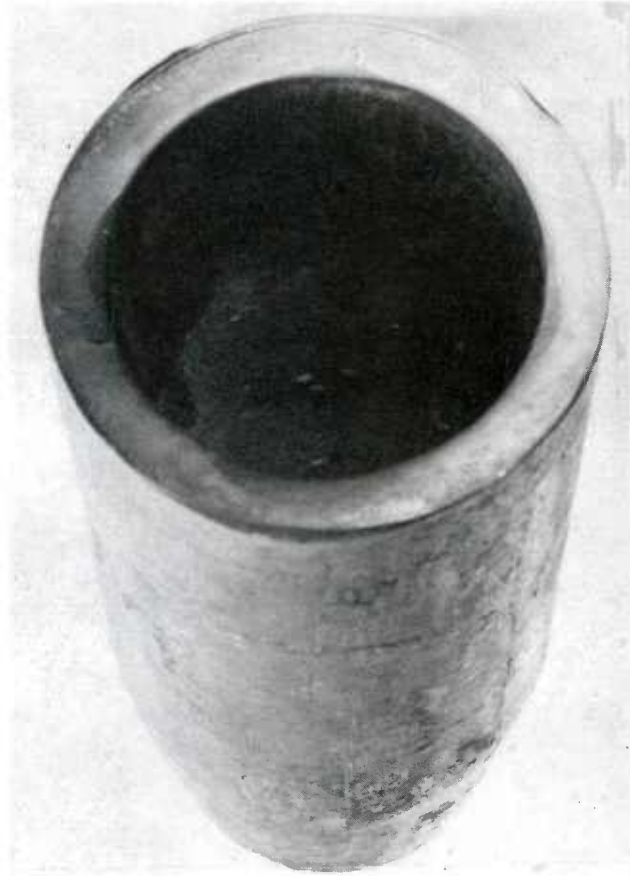
Figure 31. Blisters on cavity surface of forging made from Roblin Steel product (0.5X)

Another condition evident in forgings made from unworked continuous-cast steel is the formation of blisters on the cavity surface as shown in figure 31. Cross-sections of a blister at higher magnifications are shown in figure 32. Again, no evidence in the microstructure indicates what would cause the defect. A probable cause is that gas is trapped in voids near the center of the unworked continuous-cast steel billet. During forging, the voids are distributed next to the punch on the cavity surface. Expansion of the entrapped gas at the forging temperature causes the blisters once the support of the hot forge punch is removed.

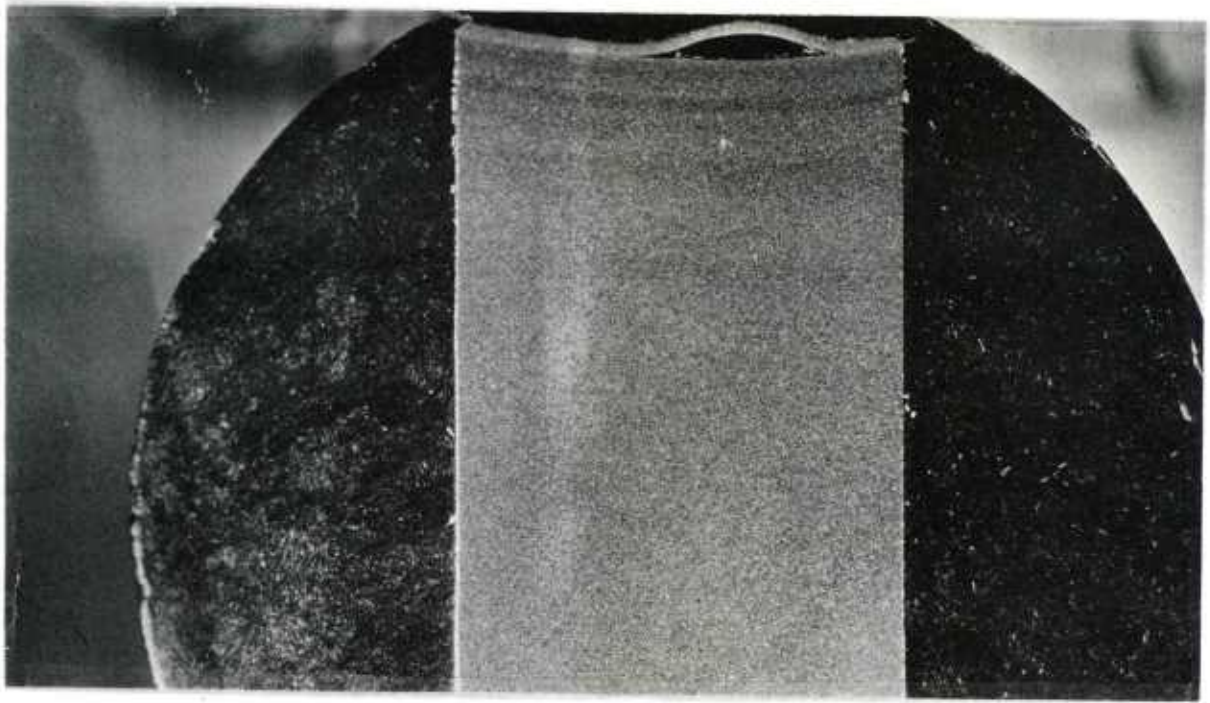
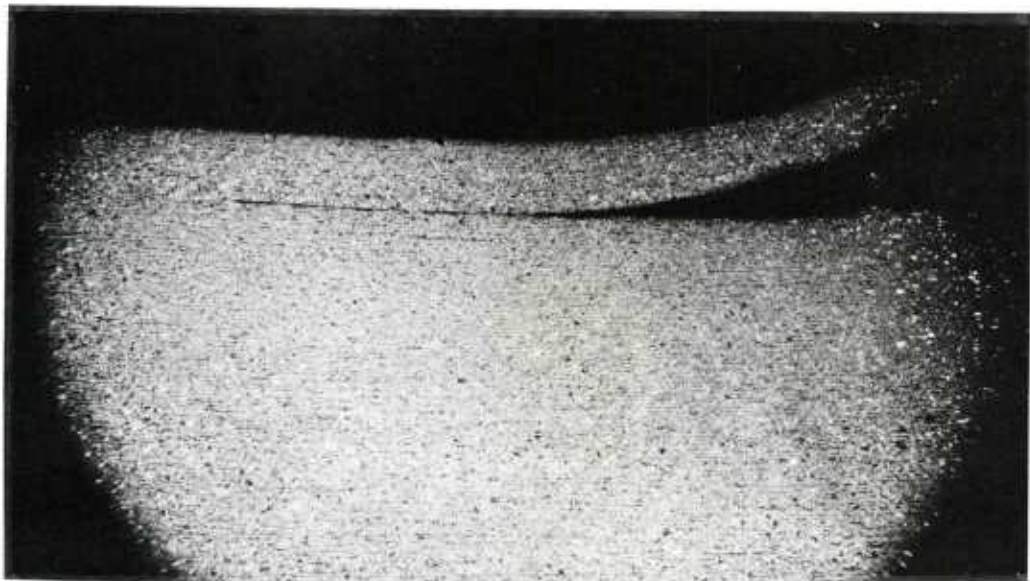
Figure 32. Cross-section of blister on cavity of forging made from Roblin Steel product (3X and 30X)

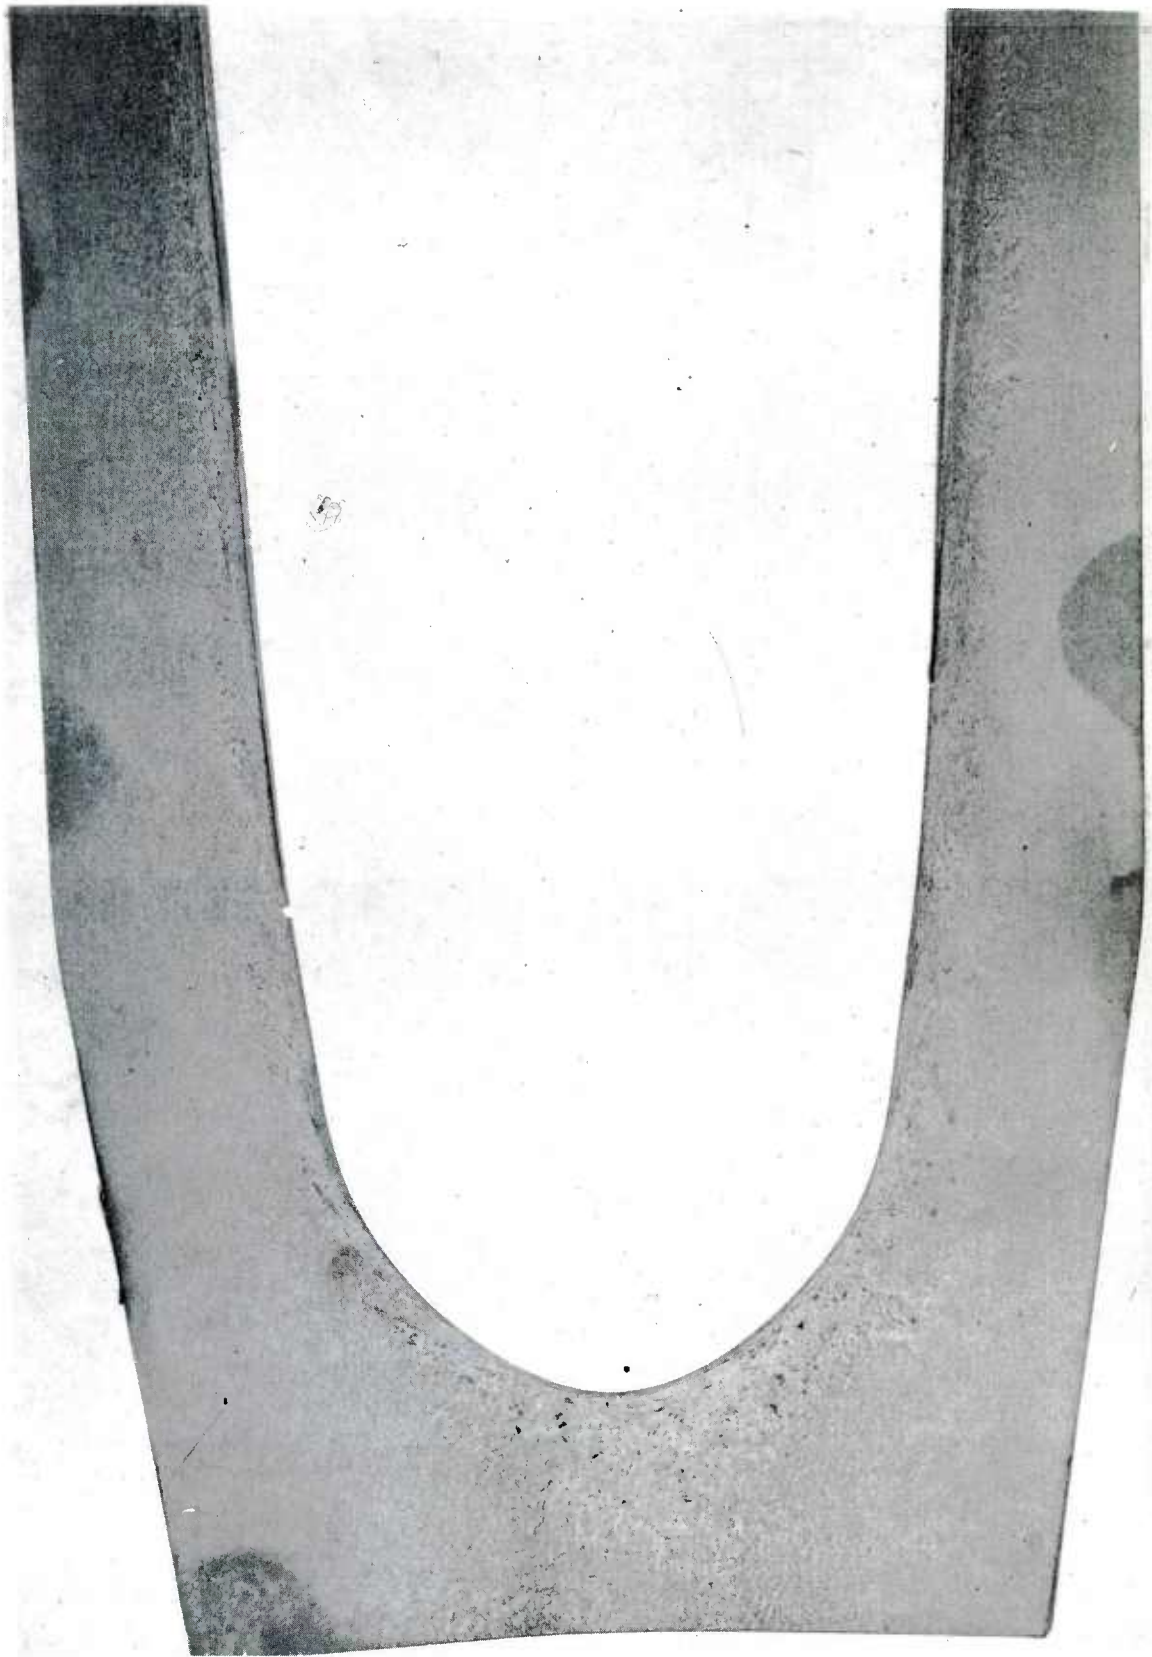
Figure 33. Macroetched section of forging made from Roblin Steel product

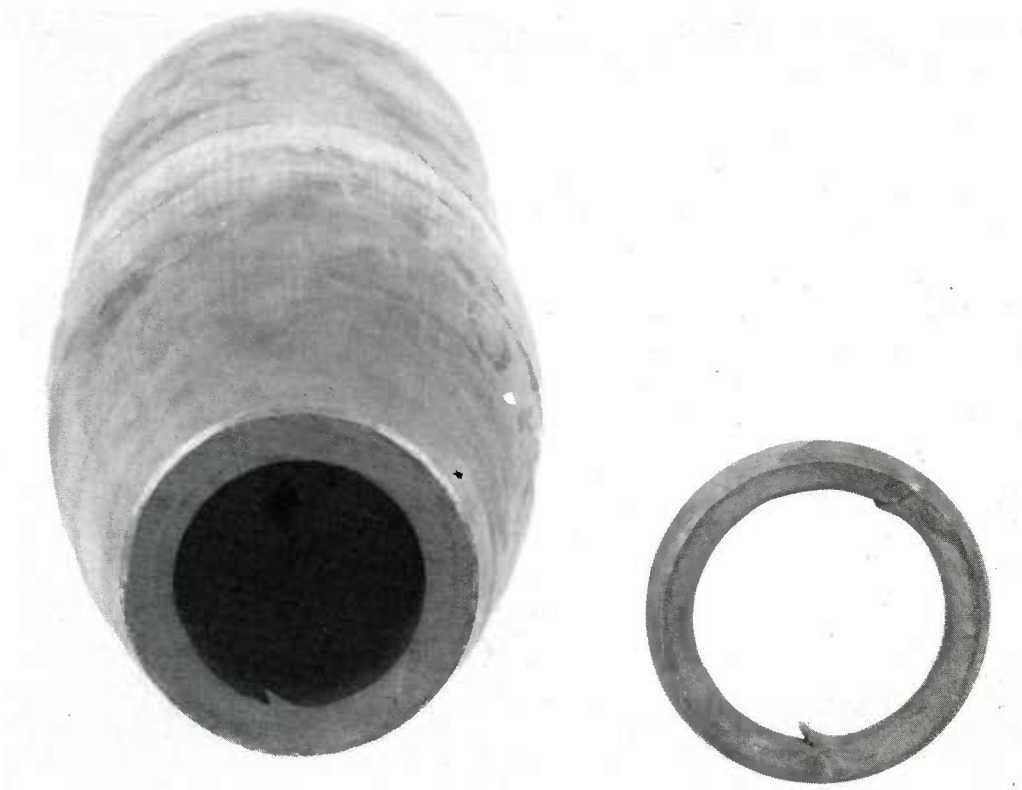
Figure 34. Nosing defect in projectile made from Roblin Steel product

A defect occurring in projectile bodies made from unworked continuous-cast steel occurring during the nosing operation and similar to those defects experienced with the Republic Steel products is shown in figure 34. Cracks similar to those shown in figures 28 and 29 could also cause this defect if not completely removed prior to cold draw and nosing.

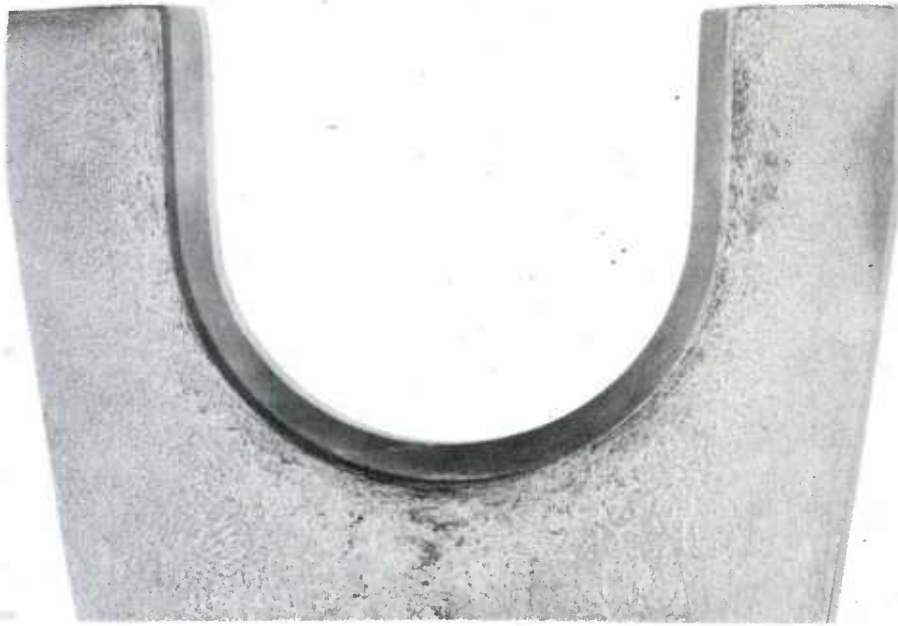
Figure 35. Macroetched base of projectile made from Roblin Steel product

The macroetched base section of a projectile body is shown in figure 35 and the dendritic structure is still evident. Some segregation is also evident. The manner in which alloy segregation affects the microstructure is shown in figure 36. The darker area in the center of the photograph has a higher percentage of pearlite, which is due to a higher concentration of manganese. Unworked continuous-cast steels are more prone to exhibit segregation because they have not been worked and reheated as has the Republic Steel continuous-cast product.

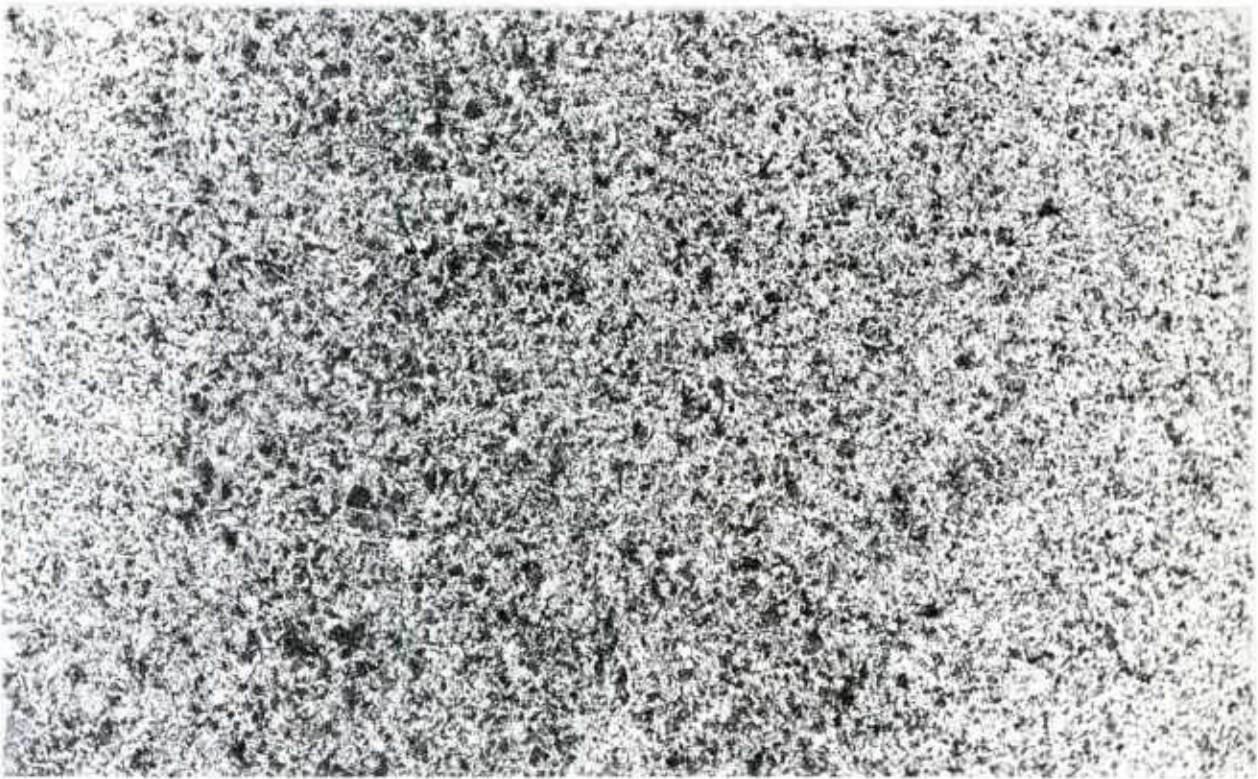
Figure 36. Microsegregation in Roblin Steel product, picral etch (100X)
